*This Home Inspection Report Has Been Prepared Exclusively For:*

## PROPERTY INSPECTION REPORT

INSPECTION ADDRESS  
**12345 Somewhere Special St.**  
**Oklahoma City, OK 73123**

This is the visual Report of the readily accessible areas of this property conducted on  
**January 2, 2008**

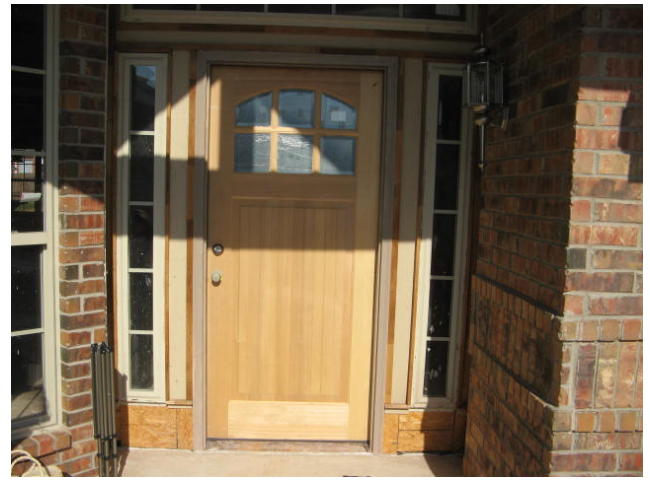
UNPAINTED ENTRY DOOR AND TRIM

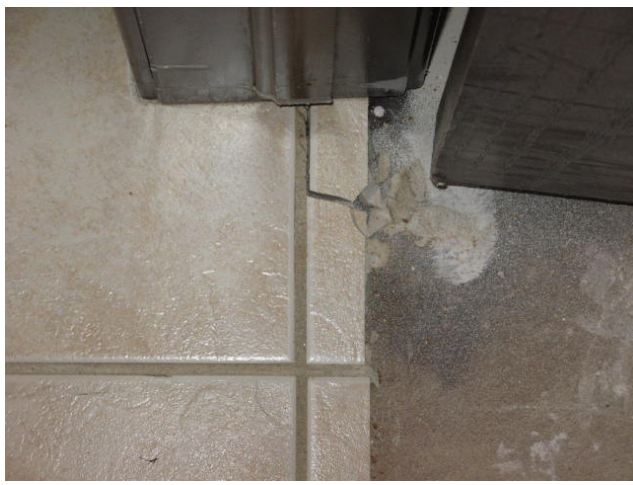
BROKEN FLOOR TILE

**DINETTE-REPLACE BROKEN FLOOR TILE BETWEEN THE LIVING AND DINETTE FLOOR**

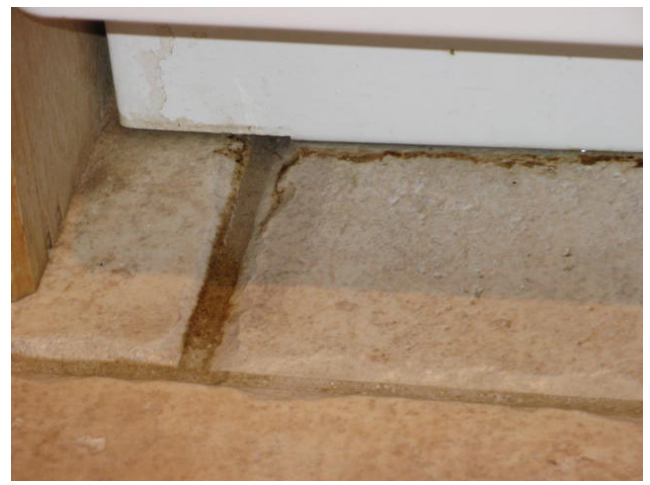
LEAKING DISHWASHER

NOTES: **DISHWASHER - REPAIR THE NOTED MINOR LEAK DUE TO COMPROMISED SEAL ACROSS THE BASE OF THE DOOR**

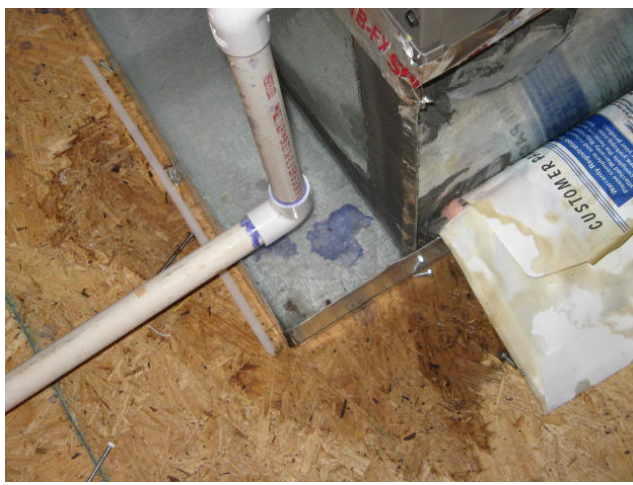
OVERFLOW DRAIN PIPING TO FURNACE FILLED WITH WATER

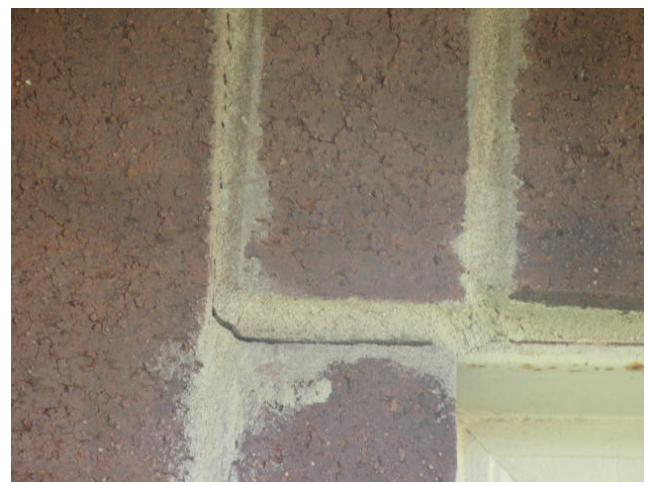
NOTES: NOTED MORTAR JOINT CRACKS-

-BELOW THE NORTH WINDOW EAST WALL  
 -ABOVE THE MASTER BATHROOM WINDOW

NOTED MORTAR JOINT CRACK

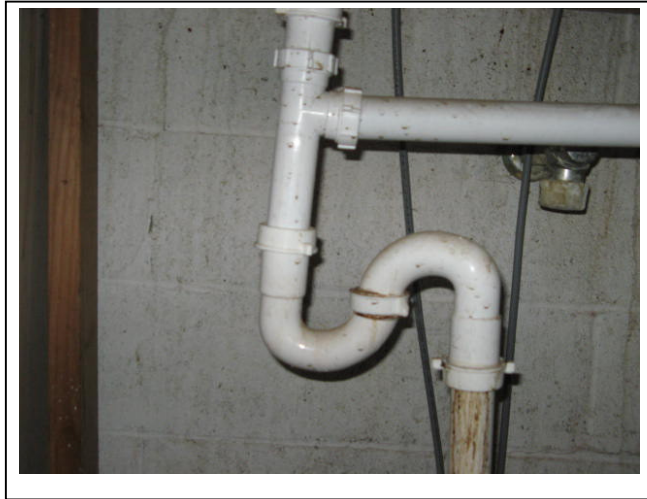
NOTED IMPROPER S-TRAP

NOTES: **GUEST BATH-PROPERLY PLUMB THE DRAIN OFF THE SINK WITH A P-TRAP INSTEAD OF THE NOTED S-TRAP THAT CAN CAUSE SIPHONING**

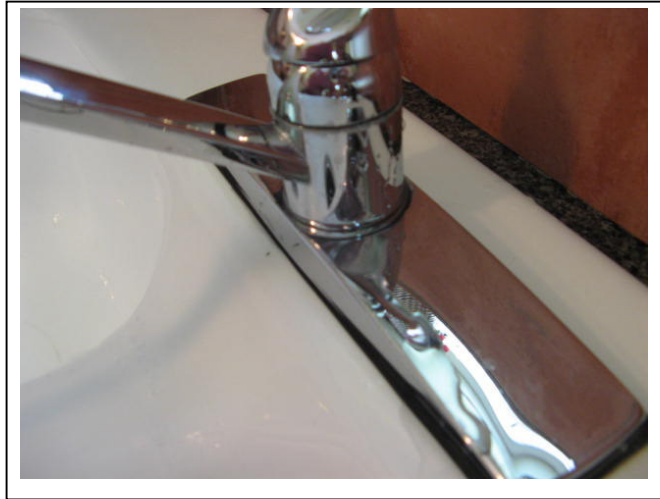
MINOR LEAK TO KITCHEN FAUCET

**KITCHEN- REPAIR THE MINOR LEAK AT THE BASE OF THE KITCHEN FAUCET**

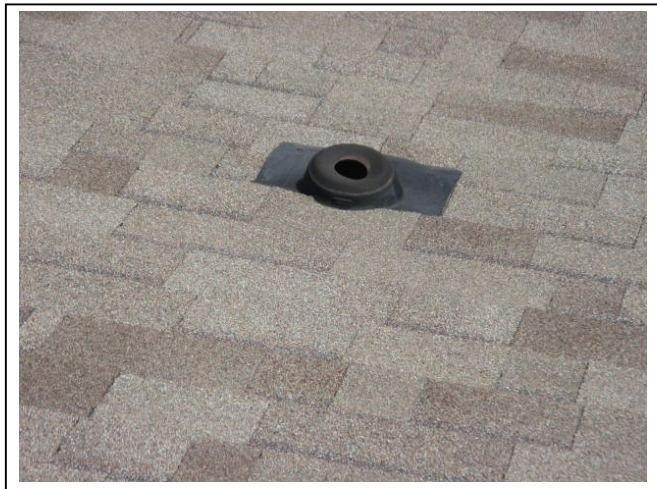
NOTES: ATTIC-VENT STACK FROM THE PLUMBING OVER KITCHEN IS LOOSE IN THE ATTIC -SEE ROOFING NOTE-

ROOF JACK WITH NO VENT STACK  
EXTENDED THROUGH THE ROOF

NOTES: **ROOF- PROPERLY EXTEND PLUMBING VENT STACK THROUGH THE ROOF JACK ON THE WEST SLOPE**

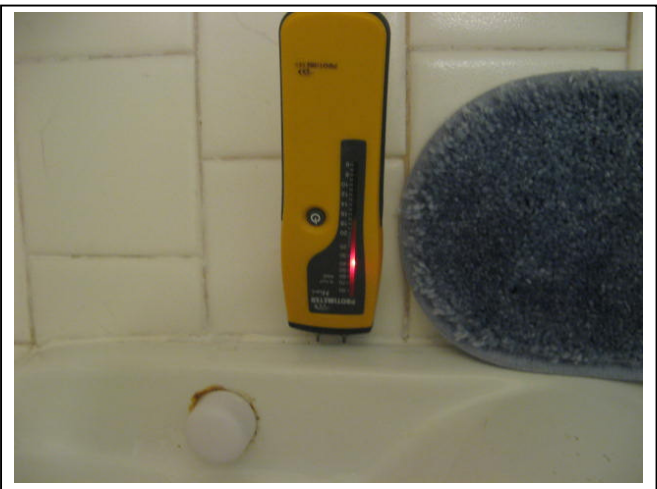
MOISTURE NOTED AROUND BASE  
OF STOOL.

NOTES: **MASTER BATH- PULL AND RESET THE TOILET DUE TO NOTED MOISTURE AROUND THE BASE AND ROCKING OF THE STOOL**

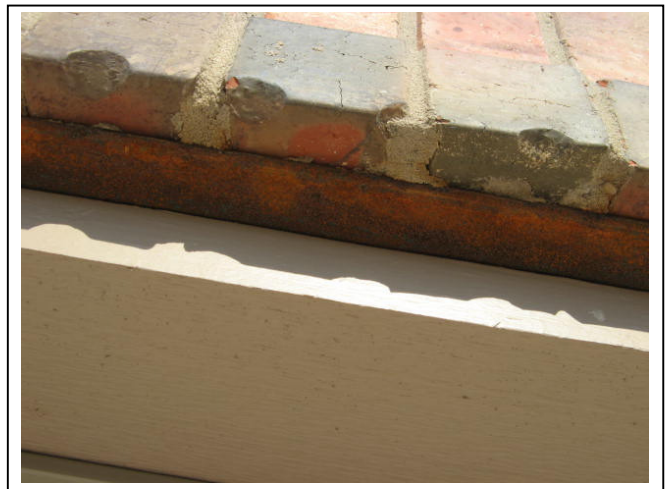
RUSTING STEEL LINTEL NEEDING  
PAINTED

EXTERIOR - PAINT THE RUSTING STEEL LINTEL ABOVE THE KITCHEN WINDOW
